# Geotechnical Reconnaissance of the 2002 Denali Fault, Alaska, Earthquake

The 2002 M7.9 Denali fault earthquake resulted in 340 km of ruptures along three separate faults, causing widespread liquefaction in the fluvial deposits of the alpine valleys of the Alaska Range and eastern lowlands of the Tanana River. Areas affected by liquefaction are largely confined to Holocene alluvial deposits, man-made embankments, and backfills. Liquefaction damage, sparse surrounding the fault rupture in the western region, was abundant and severe on the eastern rivers: the Robertson, Slana, Tok, Chisana, Nabesna and Tanana Rivers. Synthetic seismograms from a kinematic source model suggest that the eastern region of the rupture zone had elevated strong-motion levels due to rupture directivity, supporting observations of elevated geotechnical damage. We use augered soil samples and shear-wave velocity profiles made with a portable apparatus for the spectral analysis of surface waves (SASW) to characterize soil properties and stiffness at liquefaction sites and three trans-Alaska pipeline pump station accelerometer locations.

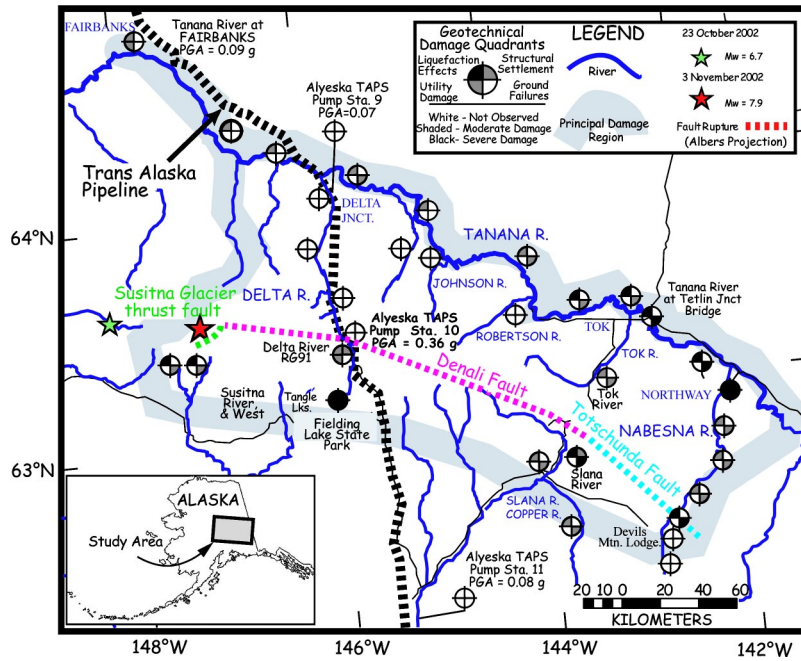
**Figure 1.** Geotechnical effects of the 3 November 2002, M7.9 Denali fault earthquake. Peak ground accelerations are presented for Fairbanks and Alyeska Pipeline Service Company facilities. The region of damaged ground covered over a 500 km wide swath of central Alaska. Details of the severity of damage effects are reported in damage quadrants described in the map legend.

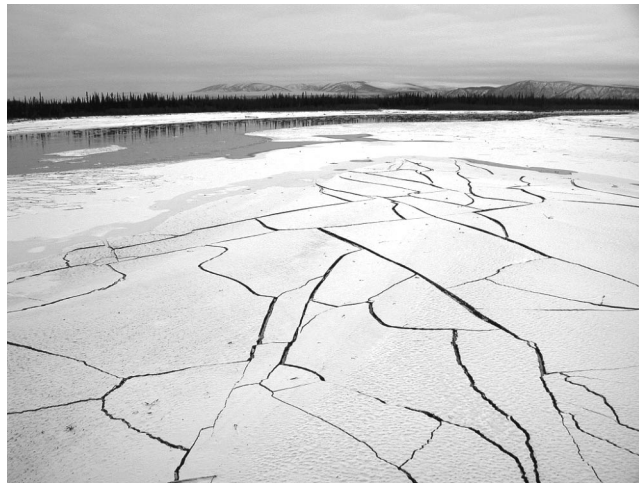
Two DGPS-measured transects along the Tanana River at Tetlin Bridge, west of Tok, showed lateral strains of 3%-4% on sand bars across distances of 200 m (21 fissures) and 400 m (48 fissures) (Figures 2 and 5). In some places the frozen crust (less than 0.3-m thick) of separate lateral spreads decoupled from the underlying soil and collided, buckled and thrust over one another resulting in contractions of as much as 4.5 m (Figure 6).

**Figure 5.** Lateral spreads on bars of the Tanana River. The crust of the bar was frozen to a depth of approximately 0.3 meters at the time of the earthquake and shattered in a polygonal pattern that was observed along several hundred miles of the river deposits (Site 588-TET, Tanana River, Tetlin Bridge, foreground field of view approximately 20 meters wide).

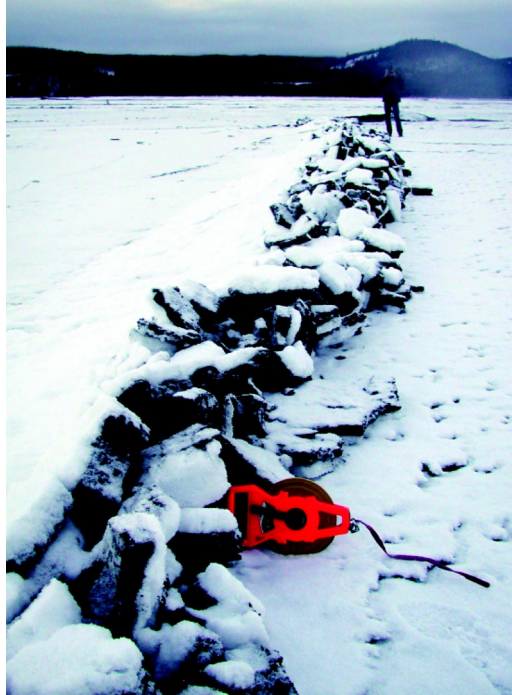
**Figure 6.** Lateral movement drove the crust down-slope where surface crust ( $\sim 0.3$  m thick) was rafted on a liquefied layer. In low-areas (here, a return channel) collision of two crusts resulted in between 3.8m and 4.3m of shortening (near SASW Site 588-TET). The tape measure handle is 15cm wide.

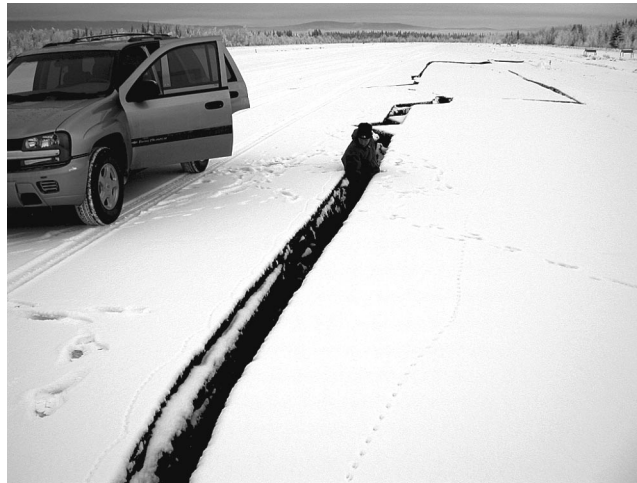
**Figure 7.** Fracture and lateral displacement of the northern end of the runway at Northway Airport (near SASW Site 582-NOR and 587-NOR). Fissures formed along the pavement seams of the runway.

100 m opened along the perimeter of the runway and vented silt, coarse to fine sand, and pebbles.

Associated with the sand vents were sinkholes as much as 4 m in diameter and 1 m deep. Residents reported water and soil rising 2 m-4 m into the air during and immediately after the earthquake. Parallel and polygonal patterns of lateral spreads similar to those observed in the Tanana River bars were observed at Northway, both in the paved runways and in the surrounding undeveloped areas. Away from the runway, houses and structures were unseated and tilted on their foundations, sand boils were ubiquitous (Figure 8), and road settlements bent and crushed drainage culverts. Shear-wave velocities for the critical layer of liquefied soil at three liquefied sites near Northway Airport were low, and ranged from 90 m/s to 150 m/s.

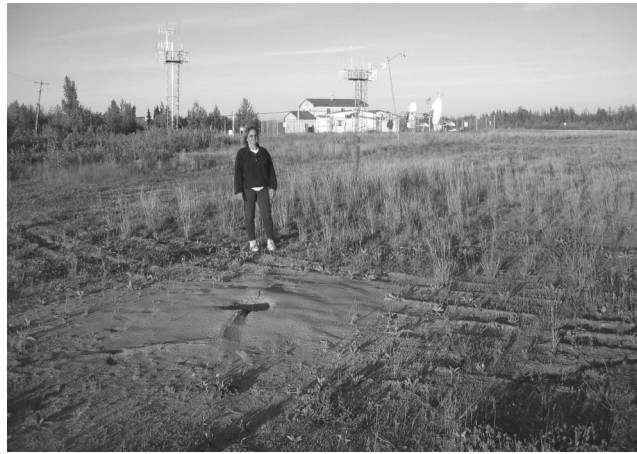
**Figure 8.** Sand boils west of Northway Airport were nearly perfectly preserved nine months after the earthquake when we returned to conduct SASW testing. During most of the intervening period, the ground and damage features remained frozen (SASW Site 587-NOR, Northway Weather Station).

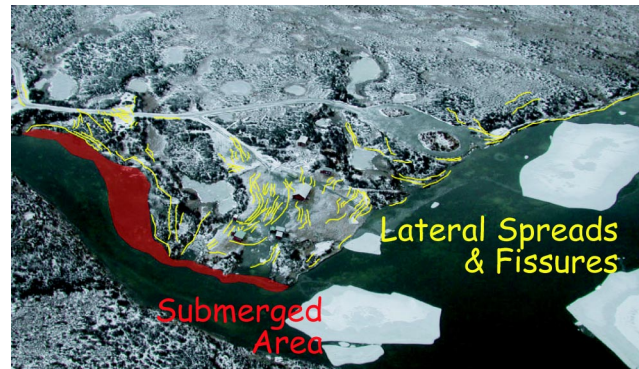
**Figure 11.** Oblique air photo of lateral spreading and fissures at Fielding Lake. The fissures are marked in yellow. A portion of the northern shoreline was laterally spread and submerged.

Fielding Lake is located on one of the headwater drainages of the Delta River, at Phelan Creek, south of the fault crossing, and within two kilometers of Isabel Pass, the drainage divide for the Alaska Range. Widespread liquefaction, lateral spreading, sand boils, and submerged ground were observed at Fielding Lake where the upper soil crust was not frozen at the time of the earthquake (Figure 11). Seen here were classic features associated with lateral spreading along a lakeshore, such as large fissures roughly parallel to the contours, and displacement of the ground towards lower areas. In areas of low-lying brush along the northeast end of the lake, at the exiting stream that drains to Phelan Creek, laterally spread and settled ground sank below lake level, submerging and drowning vegetation. Light wood-frame structures built on lateral-spreading ground were tilted and displaced down-slope, and an underground septic tank became buoyant, lifting a small out-house above the ground (Figures 12 and 13).

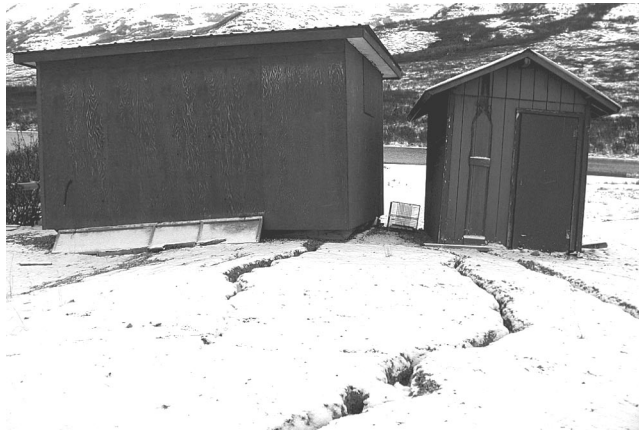
**Figure 12.** Laterally displaced ground deformed and tilted structures at Fielding Lake (SASW Site 599-FLD).

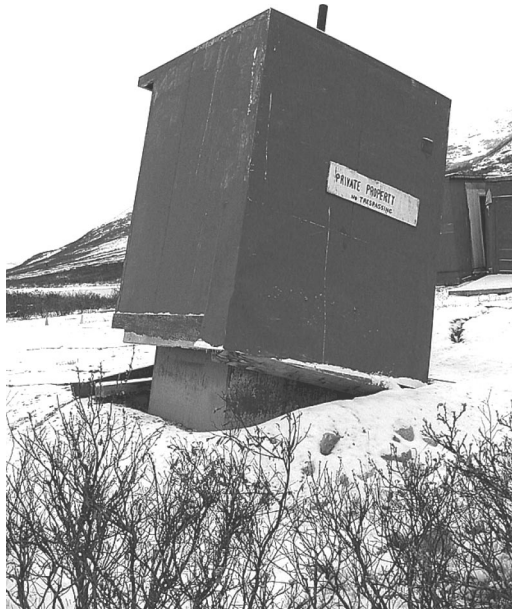
**Figure 13.** An underground septic tank at Fielding Lake became buoyant in liquefied soil lifting a small out house structure above the ground surface (SASW site 599-FLD).

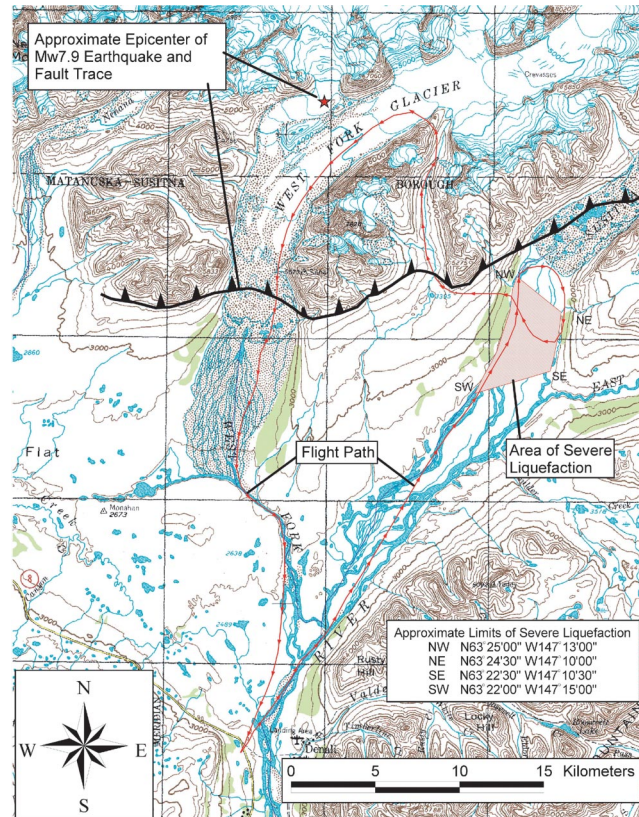
**Figure 16.** Air and surface reconnaissance of West Fork and Susitna glacier drainages identified a liquefaction field immediately south of the Susitna Glacier thrust fault near the toe of the Susitna Glacier.

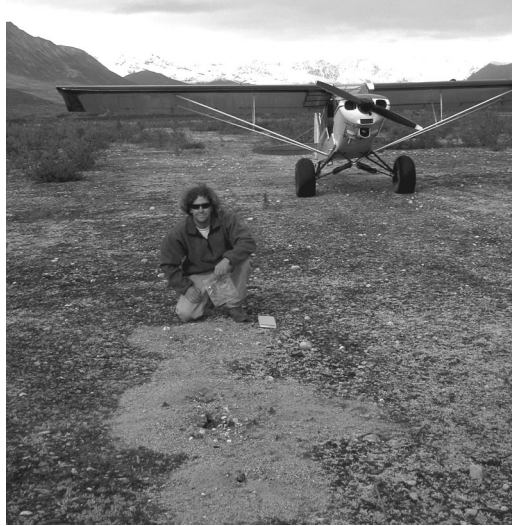
Sand boils were densely located in this area with many located along linear fissures. Some sand boils left sizeable craters up to 15-cm deep with ejecta fining away from the central crater (Figure 17). Liquefied deposits consisted of poorly graded coarse sands and well-graded sandy gravels. In some cases, the particle size of some of the ejecta was on the order of several centimeters in diameter, indicating that the severity of shaking during the event, and the rate of fluid expulsion from the liquefied layer to the surface were both high.

**Figure 17.** Sand boils in the upper Susitna River valley south of the Susitna Glacier terminal moraine.
