International Tsunami Study Team, Samoa, October 2009

Geology Team Preliminary Report 10/22/09

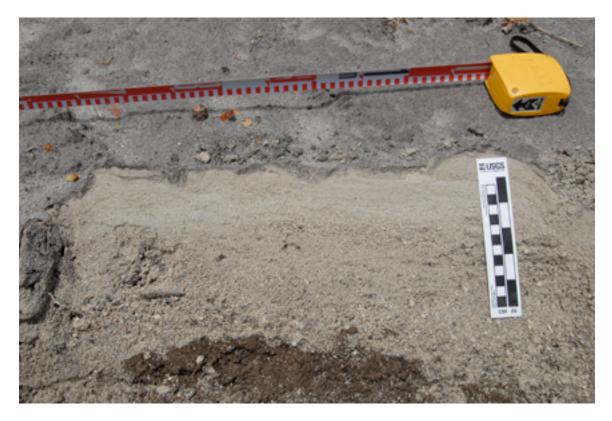
Figure 1. Shallow trench from Satitoa, Alaeipata District on the east coast showing pretsunami soil at base with sharp contact to overlying tsunami sand with multiple laminations and capped by a thin mud drape.

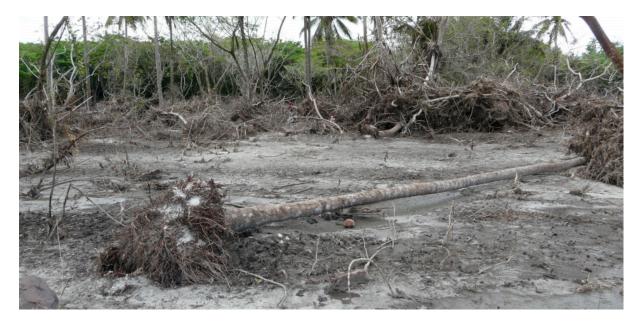
Flow direction was recorded from a number of field observations and measured by compass (either magnetic or GPS): alignment of bent vegetation (palm trees or coconut trees; figure 2), alignment of collapsed building structure (*fale* pillars or water pipes), alignment of fence posts anchored on the seaside walls of some partially destroyed building, and material such as metal roofing wrapped around tree trunks.

Figure 2. Coconut tree trunk used as a flow-direction indicator.

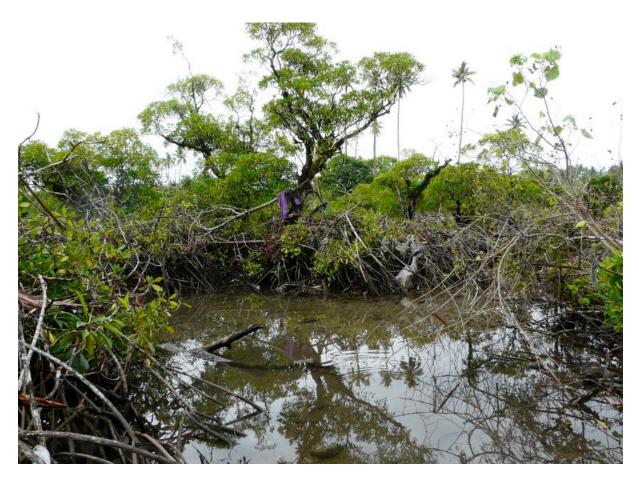
Flow depth was measured with a laser range finder using field evidences such as scratched trunk, bark removal, broken branches, rubbish trapped in branches (figure 3).

Figure 3. Clothes in a mangrove tree at Vaovai used as evidence for measuring minimum flow depth.

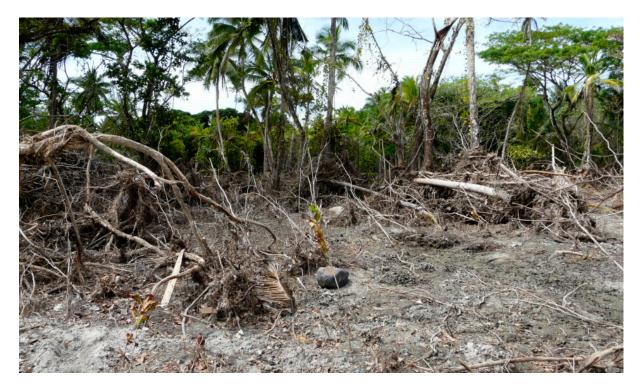
Delineation of inundation was made using GPS measurements at the marine water inundation limit. Marine inundation can be recognised in the field by observing the contact between salt-burnt yellow grass and non flooded green grass, limit of debris wrack line, and eyewitness accounts (figure 4).

Figure 4. Satitoa, Aleipata District showing vegetation debris rampart composed mostly of tree trunks and branches at the limit of inundation.

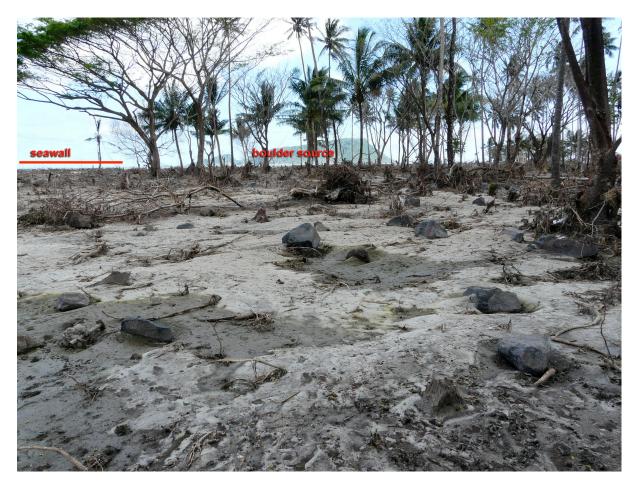
A boulder field of particular interest was investigated in Satitoa (Aleipata District, east coast Upolu; figure 5). Boulder granulometry was recorded along both transverse and longitudinal profiles, according to field evidence of the tsunami primary flow direction in this area (N340 to N010): *A*, *B*, *C* axes and long-axis orientation have been measured. A waypoint was recorded for each measured boulder. We assume that the damaged seawall along the coast road is the source for boulders. Few small rounded boulders were encountered on field, but have been rejected from the collection as they are not the usual material used in seawall engineered structure. They may come from some "marae" encountered in the surveyed area and partially damaged by the tsunami. 160 boulders were measured in this location (see results section).

Figure 5. Boulder field and sand sheet at Satitoa, Aleipata District. In the background, the seawall behaved as a source for boulders.
