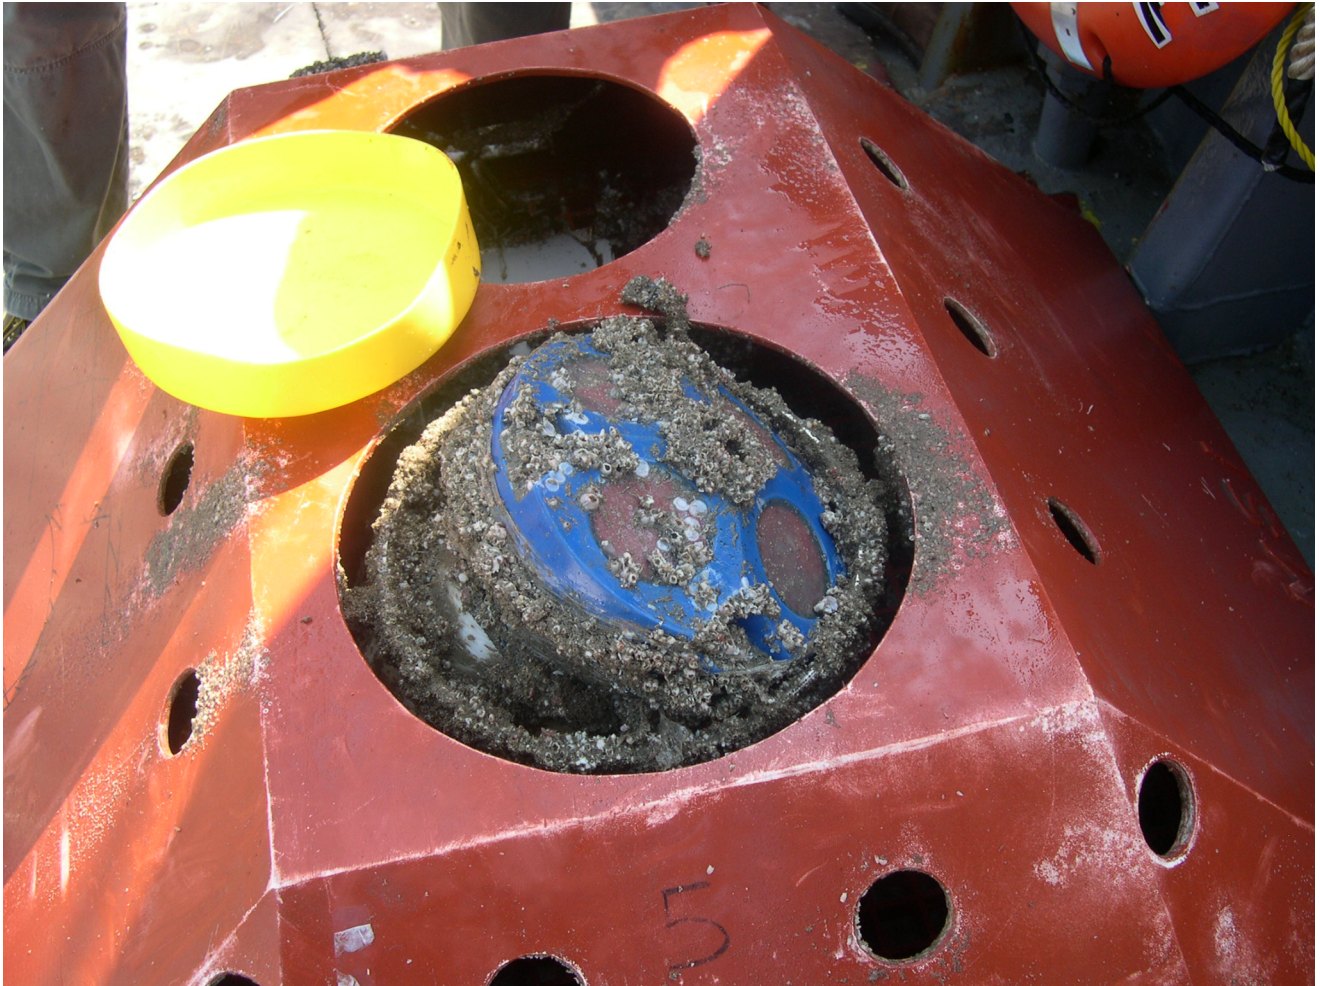
Figure 18. A post-recovery photograph of the ADCP deployed at Site 5. The ADCP was deployed in a TRBM. As seen in this photo, the ADCP became significantly tilted (>25 degrees) while in the TRBM. Data from this ADCP could not be salvaged and is not included in this report.
