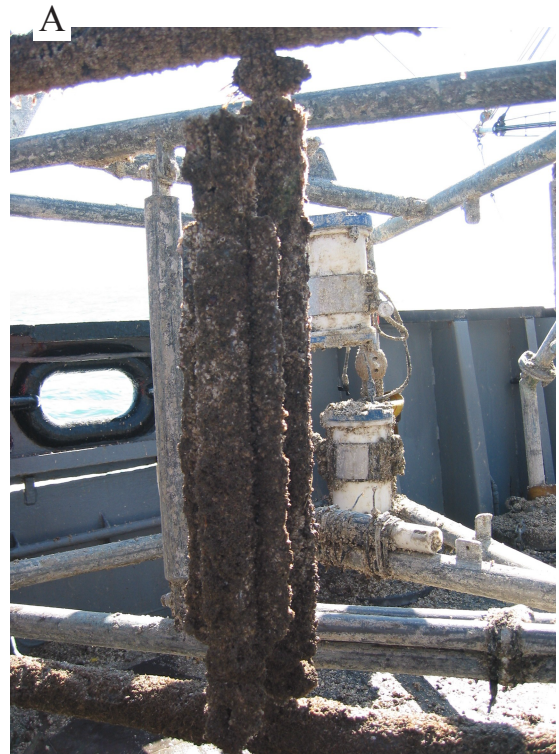
Figure 34. (A) A photograph of the tripod recovered from Site 3 at the end of the first deployment. All instruments experienced some biofouling. (B) A photograph of the ADCP mounted to the tripod shown in (A). Two of the transducers on the ADCP were biofouled (one significantly).
