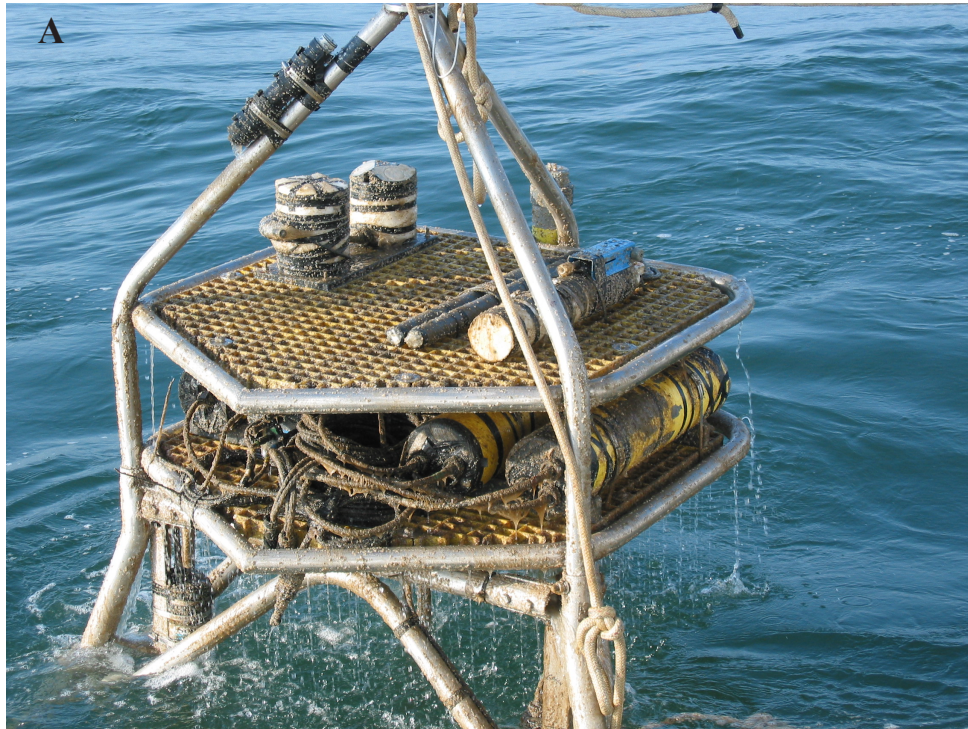
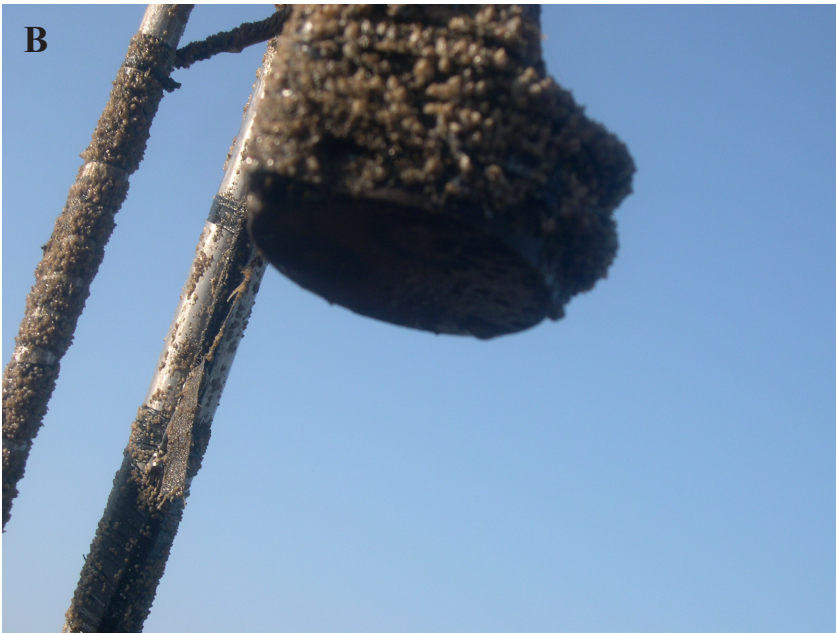
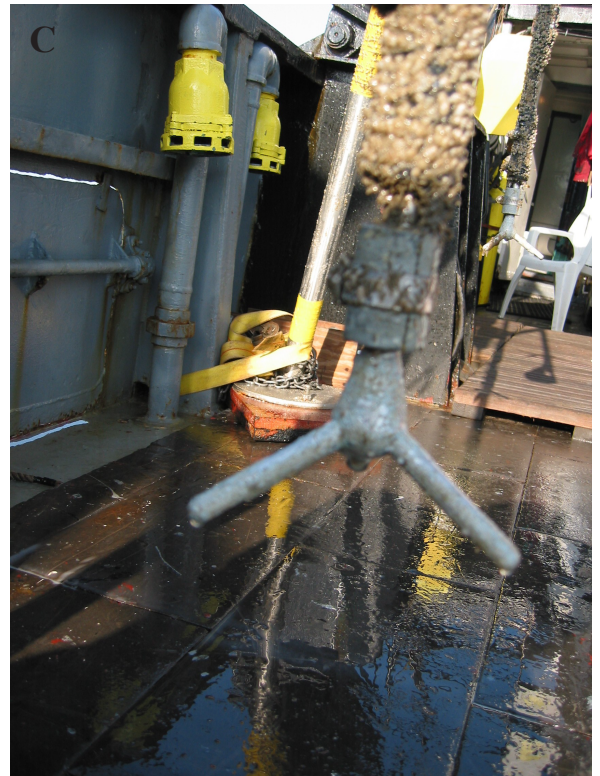
Figure 40. (A) Photograph of the tripod recovered from Site 6 at the end of the second deployment. Biofouling of the tripod surfaces and the surfaces of instruments was not significant. (B) Photograph of the ABS and (C) photograph of the ADV mounted to the tripod in (A).
