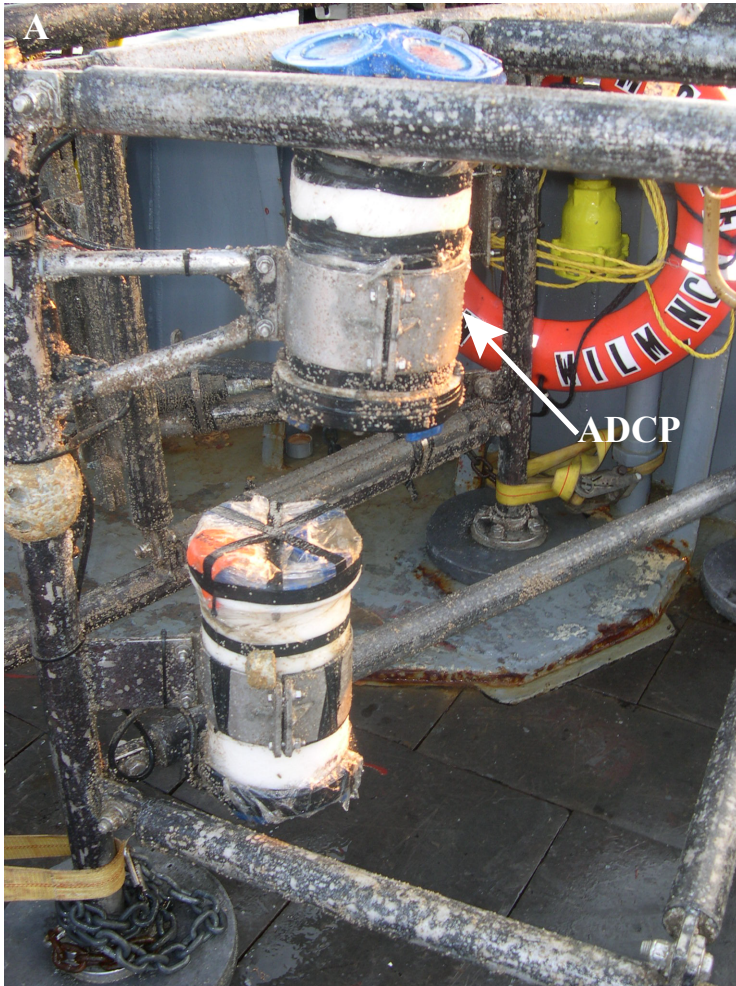
Figure 31. (A) A photograph of the tripod recovered from Site 1 at the end of the second deployment. (B) A photograph of the ADCP mounted to the tripod shown in (A). Both the ADCP and the tripod were significantly less biofouled during the second deployment.
