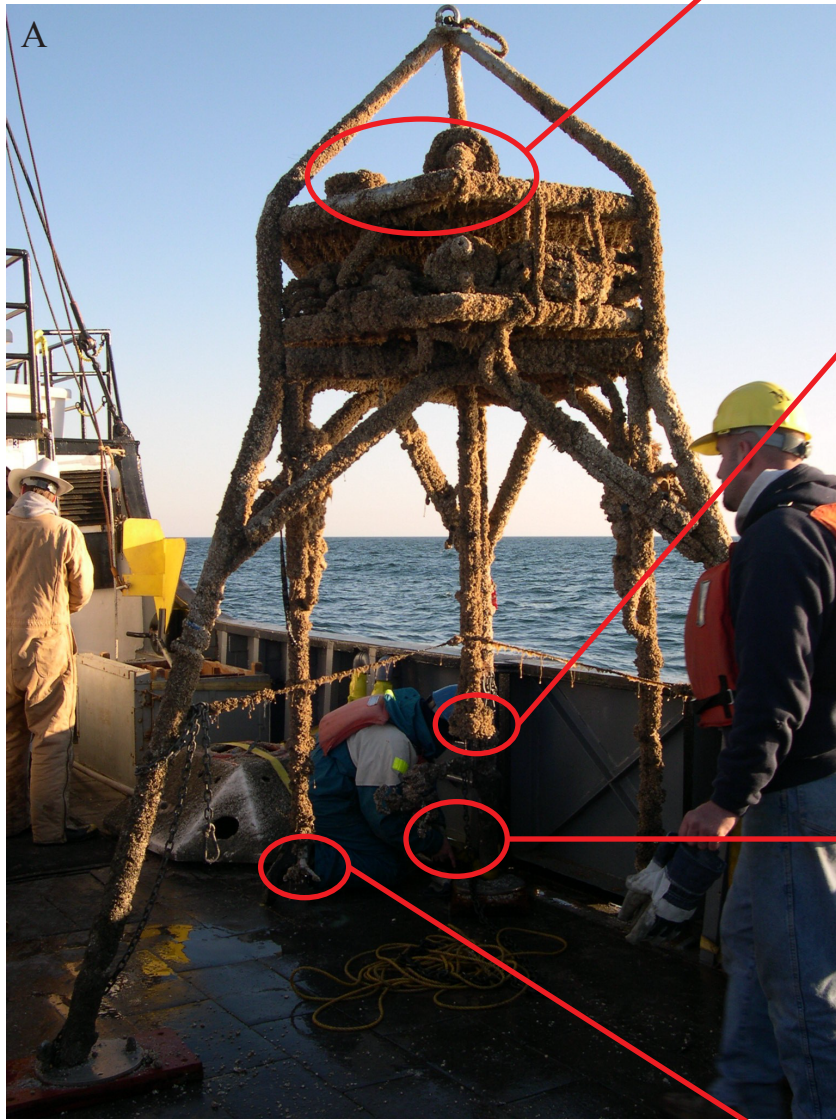
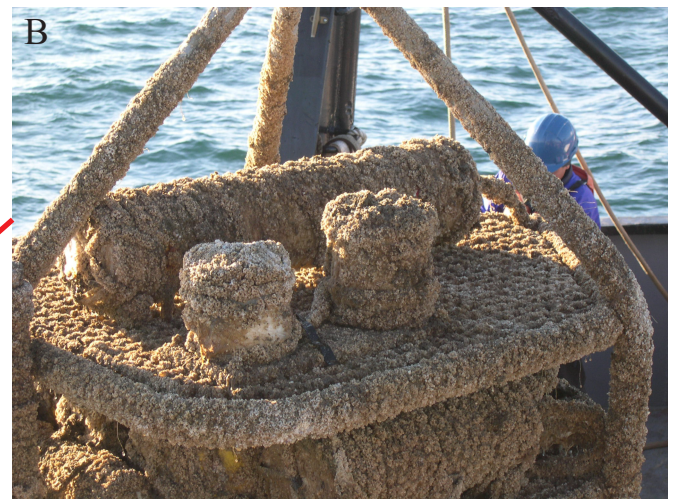
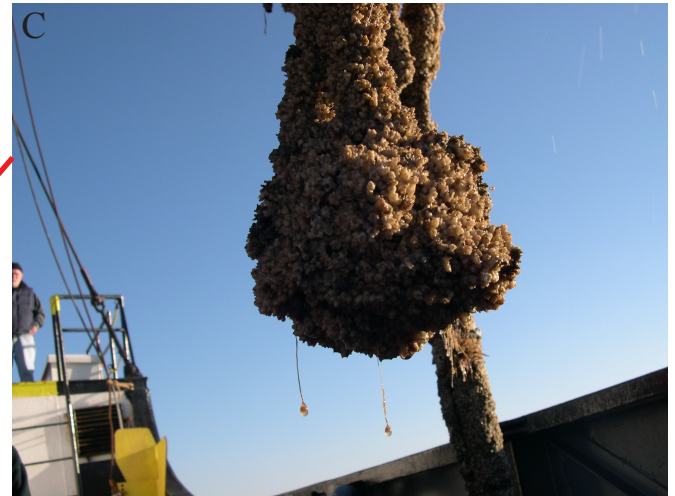
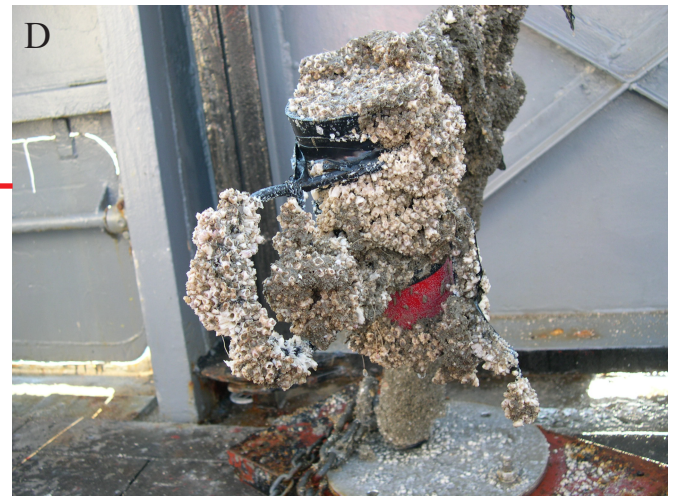
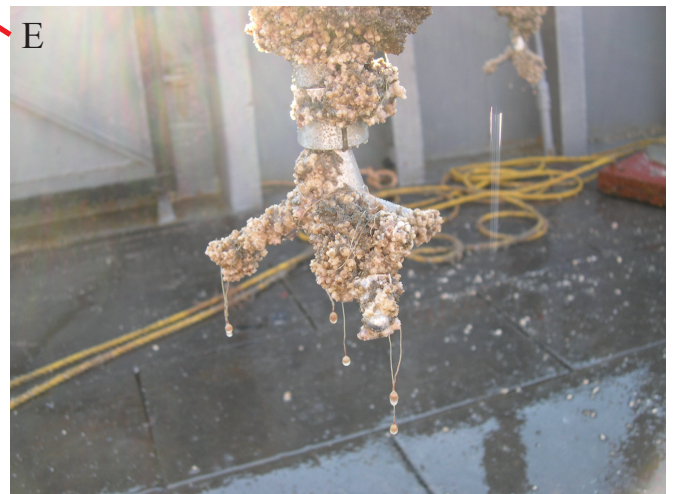
Figure 39. (A) Photographs of the tripod recovered from Site 6 at the end of the first deployment. The surfaces of the tripod and instruments are significantly biofouled. Photos of the barnacle-encrusted instruments are provided in (B) through (E).
