# Geotechnical Reconnaissance of the 2002 Denali Fault, Alaska, Earthquake

The 2002 M7.9 Denali fault earthquake resulted in 340 km of ruptures along three separate faults, causing widespread liquefaction in the fluvial deposits of the alpine valleys of the Alaska Range and eastern lowlands of the Tanana River. Areas affected by liquefaction are largely confined to Holocene alluvial deposits, man-made embankments, and backfills. Liquefaction damage, sparse surrounding the fault rupture in the western region, was abundant and severe on the eastern rivers: the Robertson, Slana, Tok, Chisana, Nabesna and Tanana Rivers. Synthetic seismograms from a kinematic source model suggest that the eastern region of the rupture zone had elevated strong-motion levels due to rupture directivity, supporting observations of elevated geotechnical damage. We use augered soil samples and shear-wave velocity profiles made with a portable apparatus for the spectral analysis of surface waves (SASW) to characterize soil properties and stiffness at liquefaction sites and three trans-Alaska pipeline pump station accelerometer locations.

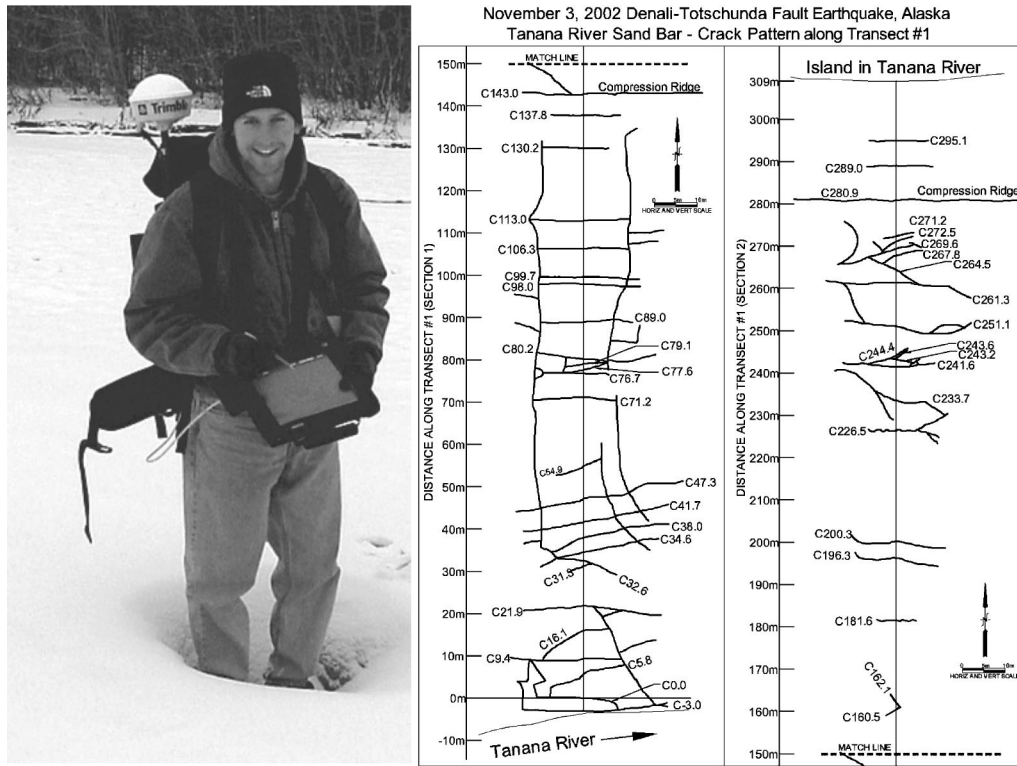
**Figure 2.** Medium precision (decimeter-scale) surveys were made using a portable differential GPS mapping unit. On the right is a detail map of lateral spreads on the Tanana River at Tetlin Junction (near SASW Site 588-TET).

Two DGPS-measured transects along the Tanana River at Tetlin Bridge, west of Tok, showed lateral strains of 3%-4% on sand bars across distances of 200 m (21 fissures) and 400 m (48 fissures) (Figures 2 and 5). In some places the frozen crust (less than 0.3-m thick) of separate lateral spreads decoupled from the underlying soil and collided, buckled and thrust over one another resulting in contractions of as much as 4.5 m (Figure 6).

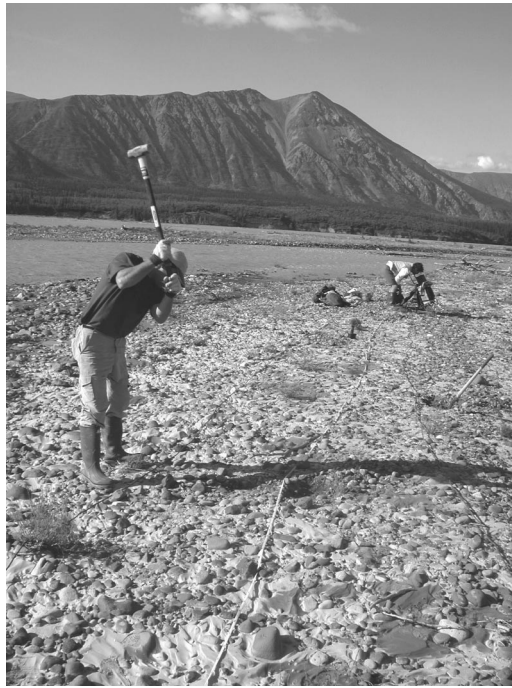
**Figure 3.** Hammer source SASW testing at site 583-NAB on the Nabesna River, a non-liquefaction site.

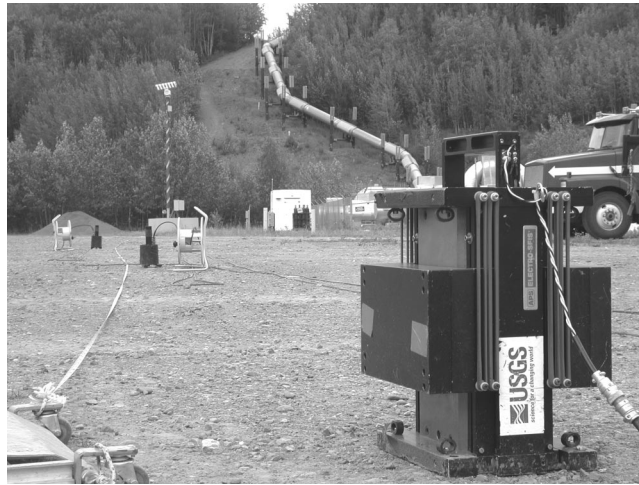
**Figure 4.** The preferred method of SASW testing uses a continuous harmonic-wave source produced by a low-frequency computer-controlled electromechanical shaker (device at right) and multi-sensor linear seismometer arrays (2-sensors on the left). This site is 600-PS11, at Trans Alaska Pipeline, Alyeska Pump Station 11, Glennallen, Alaska.

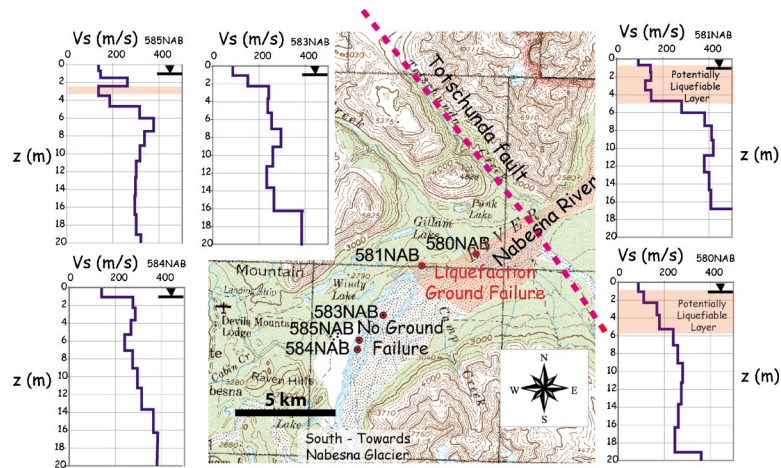
We investigated the Nabesna River deposits with SASW and auger at five sites near the fault zone and at three sites at Northway. South of the fault crossing, the texture of the near-surface deposits became finer toward the rupture zone. The shear-wave velocities computed for five sites along the river, south of the fault, also show a steady decline in value, in the upper 6 m of the soil (Figure 9). In the non-liquefied area near the glacier (sites 583NAB, 584NAB, and 585NAB) shear-wave velocities in the upper 6 m are mostly above 190 m/s, whereas north of the edge of liquefaction triggering (sites 580NAB, 581NAB) velocities fall below 160 m/s. The liquefied sites have velocities, normalized using effective stress, in the range of 157 m/s-190 m/s in the critical layer.

**Figure 9.** Mean grain size and shear wave velocity both fall down-stream (northward) from the Nabesna glacier. On the south side of the fault rupture, the shear wave profiles progressively decrease in velocity toward the fault. Low shear wave velocities in sand and gravel (red zone) indicate potentially liquefiable near-surface strata.

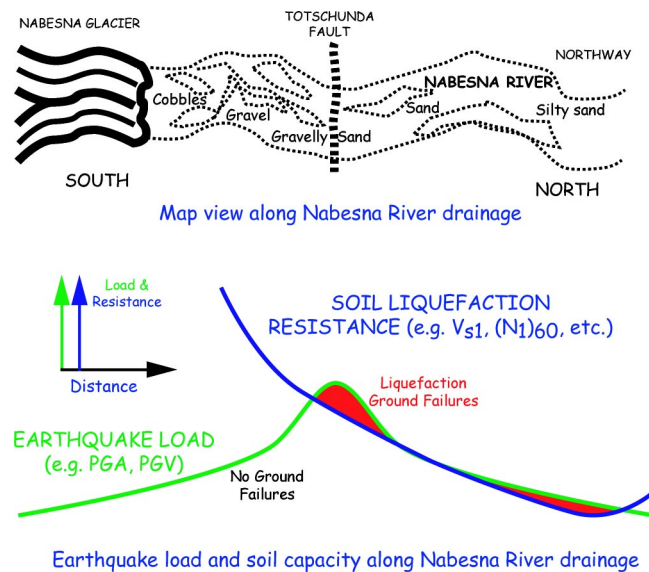
**Figure 10.** Conceptual diagram of the relation between earthquake load and soil liquefaction resistance. On the south side of the fault, rising ground motion intensity intersects falling soil liquefaction resistance: the transition zone into liquefaction is abrupt. On the north side of the fault, ground motion intensity and liquefaction resistance both fall in tandem. Areas where load exceeds capacity result in liquefaction ground failures.

The asymmetrical liquefaction patterns across the fault rupture zone are explained by the combination of the earthquake motion attenuation curve and the soil liquefaction resistance capacity curve. For a given geologic unit (e.g. young Holocene river deposits), attenuation of motion is dependent upon a function of depth of rupture and distance from the fault. Events with deep-rupture depths tend to flatten the attenuation curve in areas close to the fault zone, while lowering the amplitude of motion. For shallow events, or surface-rupturing events like the Denali fault earthquake, motion typically attenuates more rapidly with distance from the fault, often commencing close to the fault zone. For near-vertical strike-slip faults it is likely that the attenuation pattern of ground motion intensity will be symmetrical about the axis of the rupture zone (Boore et al. 1997).

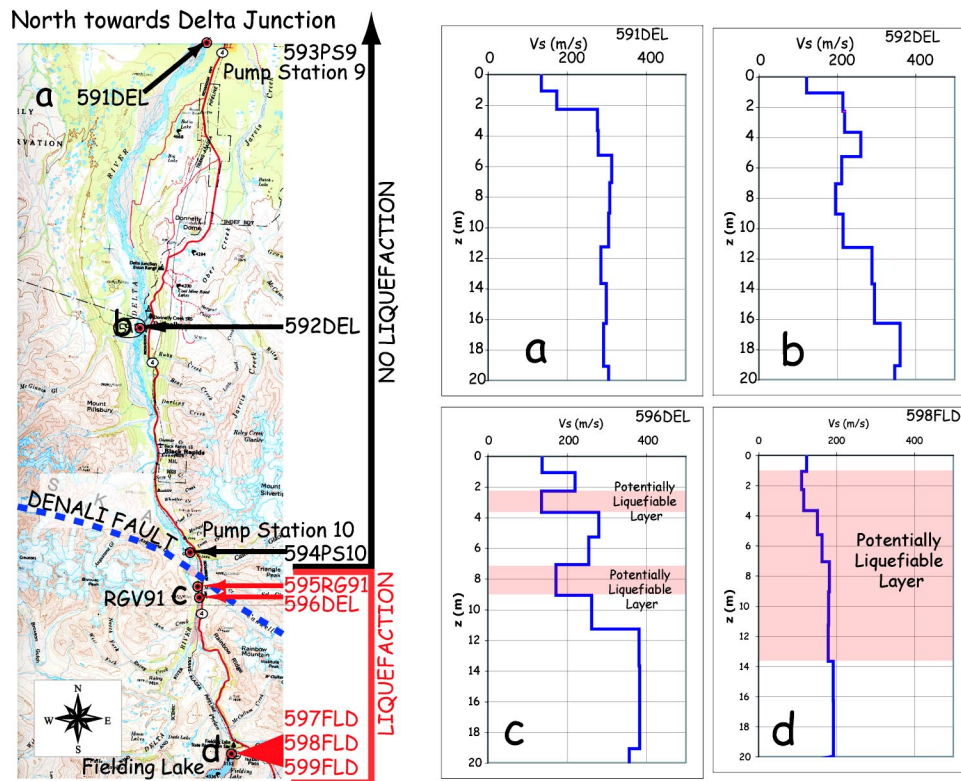
At Fielding Lake, we augured several holes to sample the liquefied zone and measured three SASW-based shear-wave velocity profiles, all with similar characteristics. The liquefiable soil layer at Fielding Lake is a low-plasticity, silty sand in the upper 3 m, underlain by a stiffer gravelly sand. The shear-wave velocity of the critical layer was in the range of 111 m/s-125 m/s, and is extremely low when compared with other documented sites that have liquefied during past earthquakes (Kayen et al. 2003) and accounts for the severity of ground displacements observed at the park (Figure 14).

**Figure 14.** SASW-derived shear wave velocity profiles for four sites in the Delta River region of the central Alaska Range.

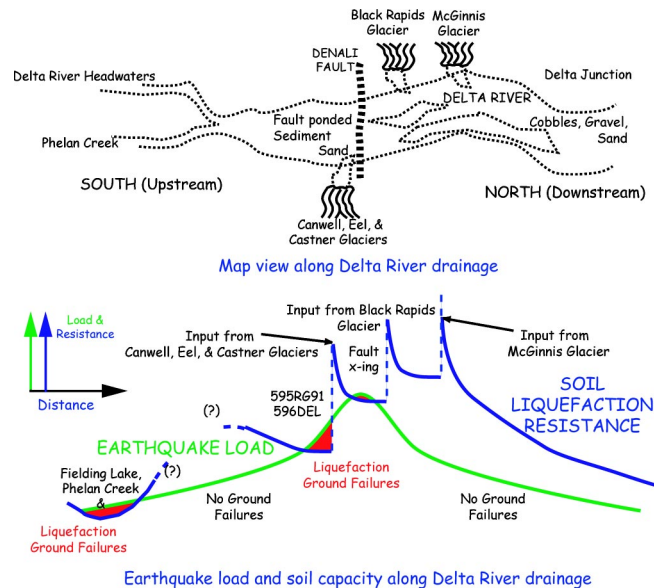
A conceptual profile of the relationship between earthquake motion loads and soil liquefaction resistance is presented in Figure 15. The geotechnical environment along the Delta River valley is more complex than along the Nabesna River valley because it has numerous side-entering glacial valleys bringing a significant load into the main-stem of the Delta River and altering the textural composition and liquefaction resistance. Liquefaction occurs at, and south of, the fault rupture upstream of glacial rivers that deposit cobble and gravel-rich poorly-sorted sediment into the Delta River.

**Figure 15.** Conceptual diagram of the relation between earthquake load and soil liquefaction resistance capacity for the Delta River drainage. Areas where load exceeds capacity result in liquefaction ground failures. On the Delta River, the falling capacity is punctuated by abrupt inputs of poorly sorted material from side entering canyons. These inputs elevate the resistance capacity of the soil above loads imparted by the Denali fault event.

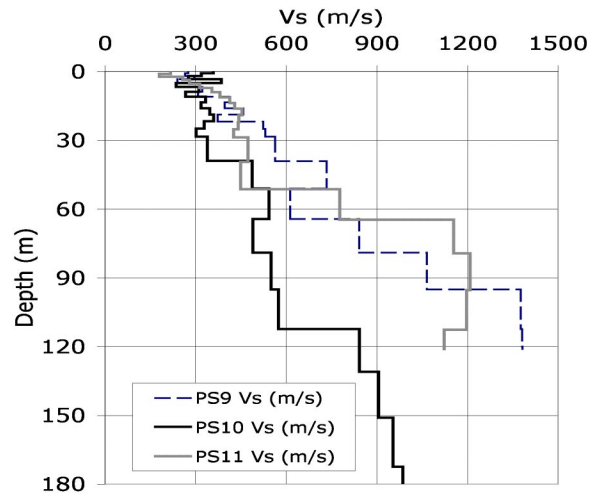
Pump Station 10 (site PS10) is an inactive facility approximately 3 km north of the rupture. It was taken off-line six years before the earthquake. At the time of the event, the facility piping, vessels and storage tanks were empty, and the station did not sustain any structural damage (Hall et al. 2003). Boreholes to a depth of 30 m show the deposits to be coarse, non-cohesive soil ranging from gravely sand to silty gravel and up to boulders (National Soil Service 1971). The average blow count of the upper 30 m is about 50. As with PS9, the surface-wave transmission at PS10 was excellent and we were able to capture wavelengths of up to 720 m (2300 ft). Indeed, data collection was so successful at this site that only the physical limitations of pump station dimension and cable length prevented collection of longer-wavelength data. The average shear-wave velocity for PS10 in the upper 30 m is 316 m/s, and shear-wave velocity exceeds 600 m/s at a depth of about 115 m (Figure 18). Thus the soil is classified as IBC2003 site classification D.

**Figure 18.** Shear wave velocity structure of Trans-Alaska Pipeline Pump Stations PS9, PS10 and PS11. Velocity profiles were inverted from active and passive array surface wave dispersion data.

The pipeline at site PS11 is located on a graded and terraced platform immediately south of the town of Glennallen. Here, the pipeline drops off a steep, incised, hill slope of ground moraine onto a flat alluvial pad prepared for the station. The fault is located approximately 125 km–150 km to the north. At PS11, we measured surface-wave wavelengths up to 300 m (about 1,000 ft). The 30-m average shear-wave velocity for Pump Station 11 is 362 m/s, giving the site an IBC2003 site classification of C at C/D boundary (Figure 18).

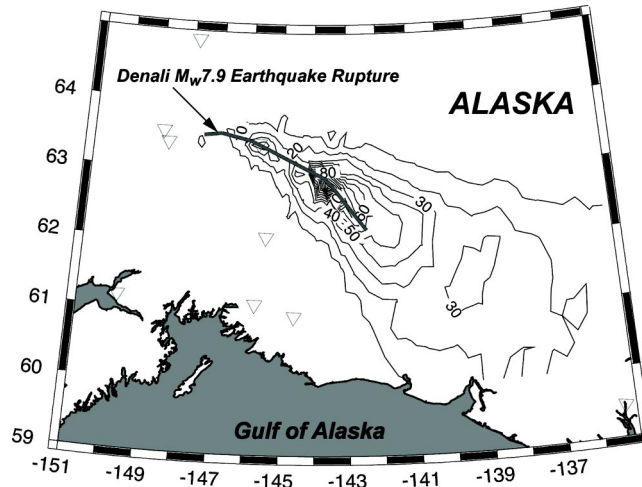
**Figure 19.** Map showing the 5-segment fault model (bold), and locations of seismic stations (triangles) used to determine a kinematic rupture model (e.g. Dreger et al., 2004). Peak ground velocity (PGV) contours derived from the kinematic source model are computed following the method of Dreger and Kaverina (2000). The contour interval is 10 cm/s (thin lines). The eastward expanding cone of PGV contours show the effect of unilateral rupture.

effects and the greater fault slip there. Though strong-motion records are sparse, seismograms derived from kinematic source models of the earthquake rupture process support the field observations of more concentrated and severe liquefaction features in the eastern portion of the damage area. These seismograms are generated from the inversion of regional seismic waveform data and GPS deformation data. The kinematic source model is described in detail in Dreger et al. (2004) and Oglesby et al. (2004). Peak ground velocities (PGV) in the geotechnical damage region were calculated using the method described in Dreger and Kaverina (2000) and are plotted in Figure 19. The area of high ground velocity, greater than 10 cm/s, extends several hundred kilometers to the east and approximately 100 km northward and southward of the easternmost extent of the ruptured Totschunda fault. The PGV contours showing this expanding area of strong motion toward the east are approximately symmetric about the fault. The seismic waveform data for the inversion is low-pass filtered at 0.5 Hz, and consequently the PGV is band limited.

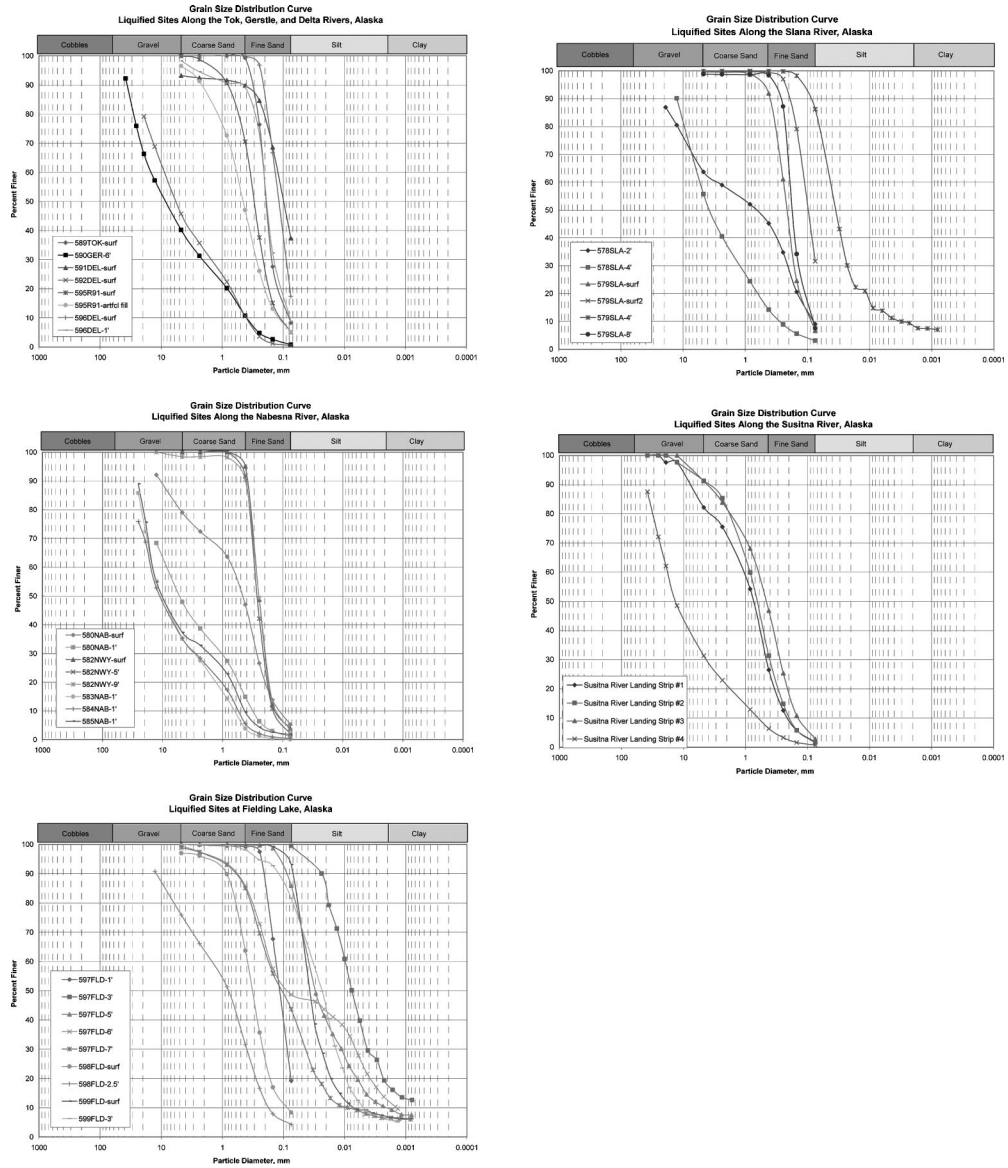
Figure A1. Cumulative grain size distribution curves for auger and surface samples taken at test sites throughout central Alaska. Refer to Table A2 for GPS locations of observed damage and test sites.
